# Holy Trinity Church

*Avonside, Christchurch*

## CONSERVATION PLAN

6 March 2009

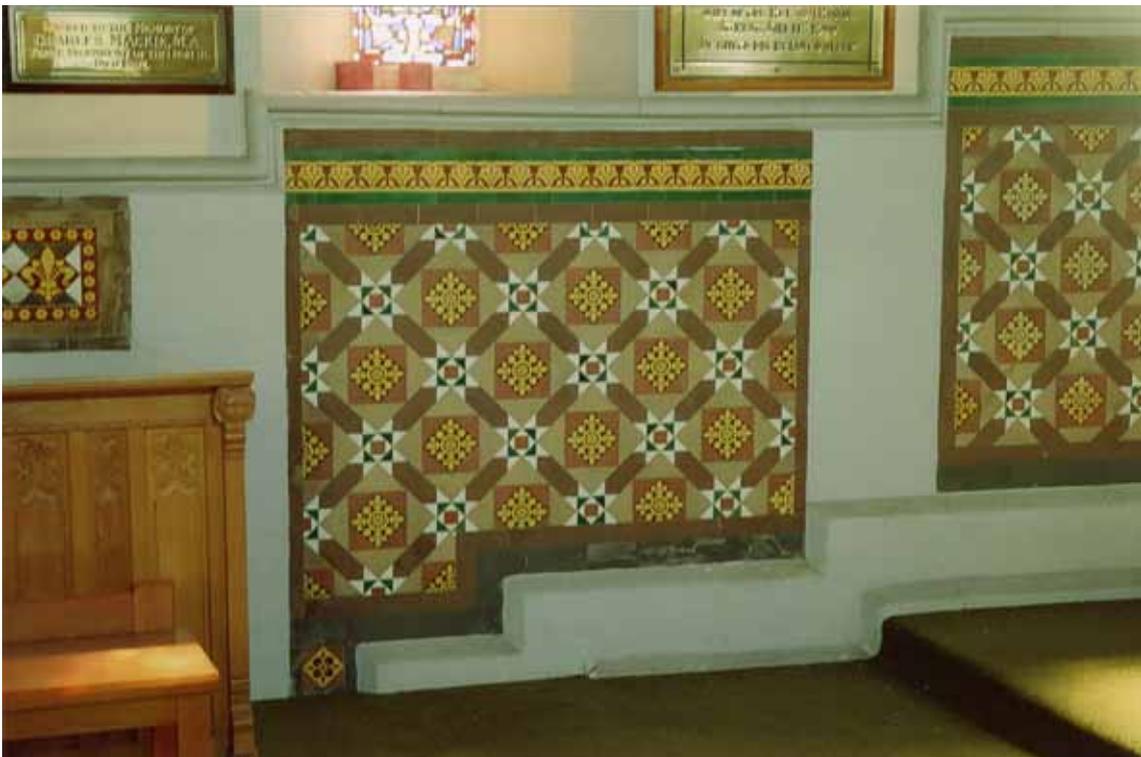
Wall Tiles, North Wall. Note the plinth below the tiles, which gives the profile of two steps that have been built over.

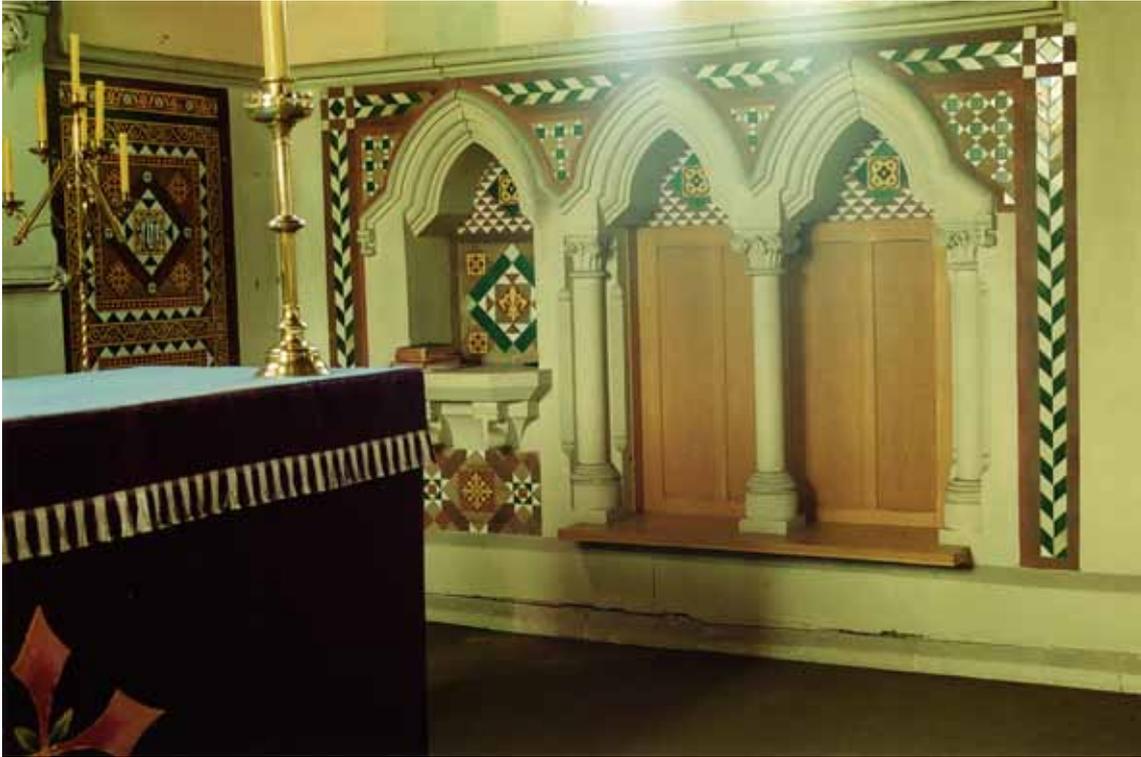
Blind Arcade, South Wall. The two timber panels to be removed; it is likely that tiles will be in place underneath.

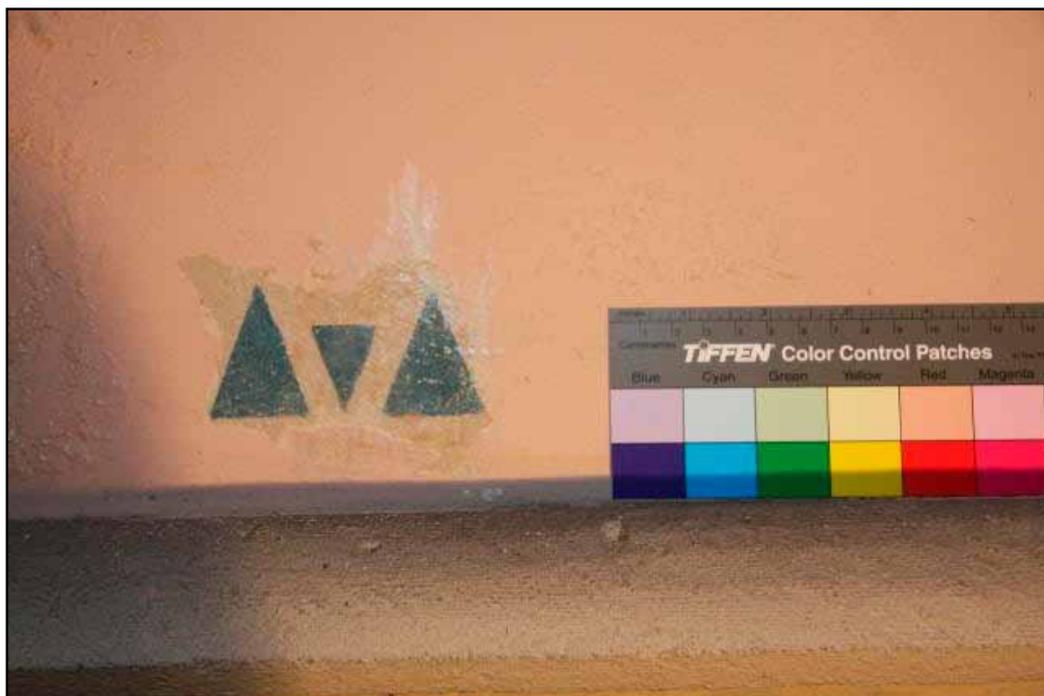
As elsewhere in the church, there is strong evidence of falling and rising damp affecting the plaster and paint surfaces of walls. Blistering of paint layers, efflorescence and 'drumminess' in render surfaces attest to issues caused by water vapour pushing through from the stonework or migrating along the wall surfaces.

Tide marks under the joist heads also show that from time to time rain water finds (or has found) access to the interior at these points.

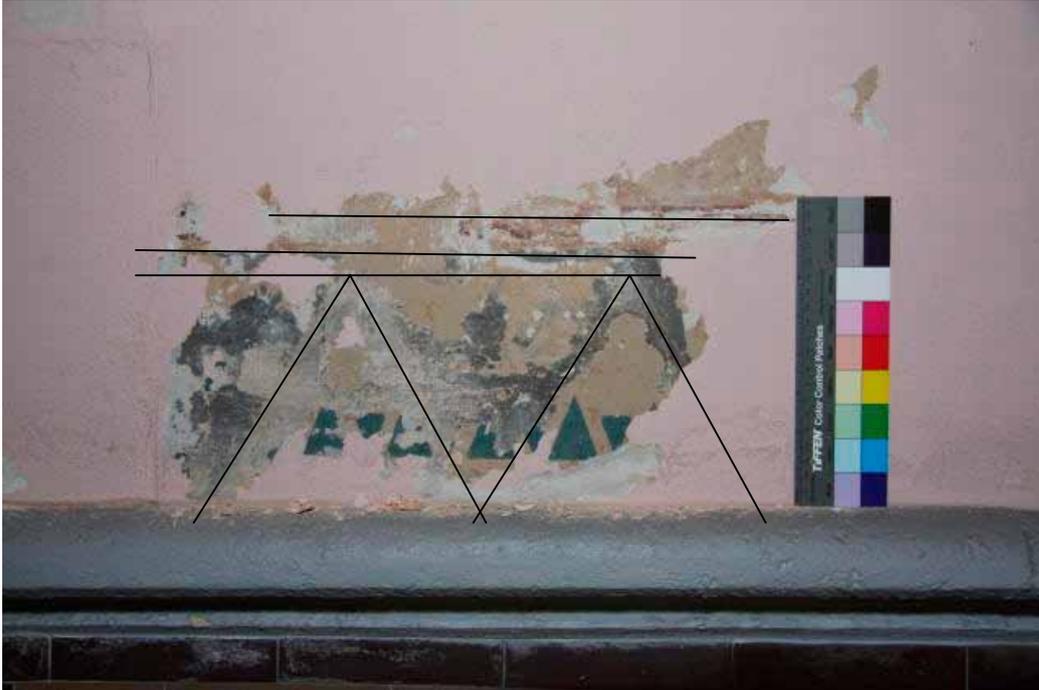
### Sample Area A

A small area was revealed using a scalpel. This showed the original colour scheme as shown in the image below, as well as an over painted layer of grey-green paint with blue stenciled triangles onto it. Over this were two layers of pink paint.

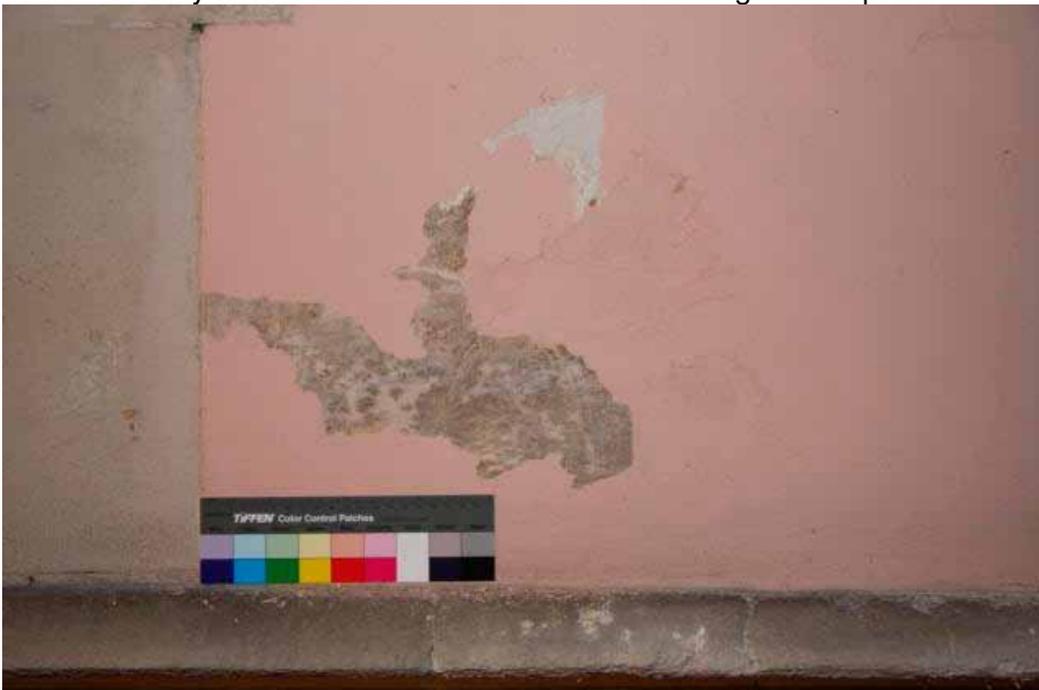
### Sample Area B

An area was revealed using paint stripper. No pattern was revealed but a small remnant of red paint was found. The grey-green layer was not present here and so this area may have suffered more recent water damage and repairs.

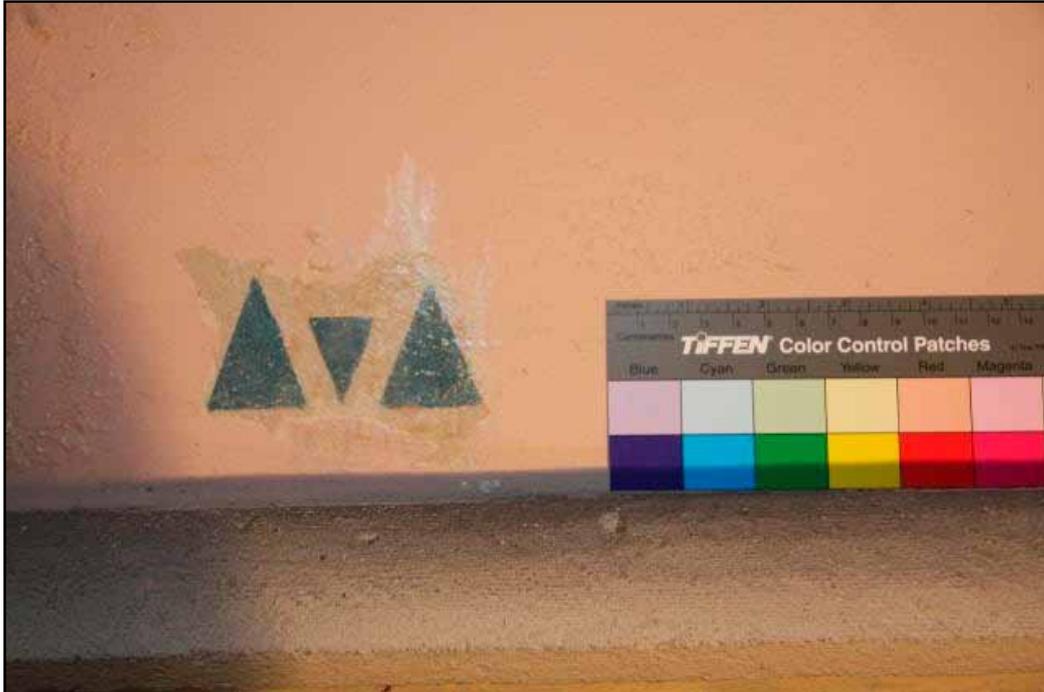
### Sample Area C

An area of paintwork beneath the pink layers of paint was revealed by Chris Cochran previous to the present investigation. This showed a green-grey background with blue triangular stenciling over the top. This is not the original scheme.

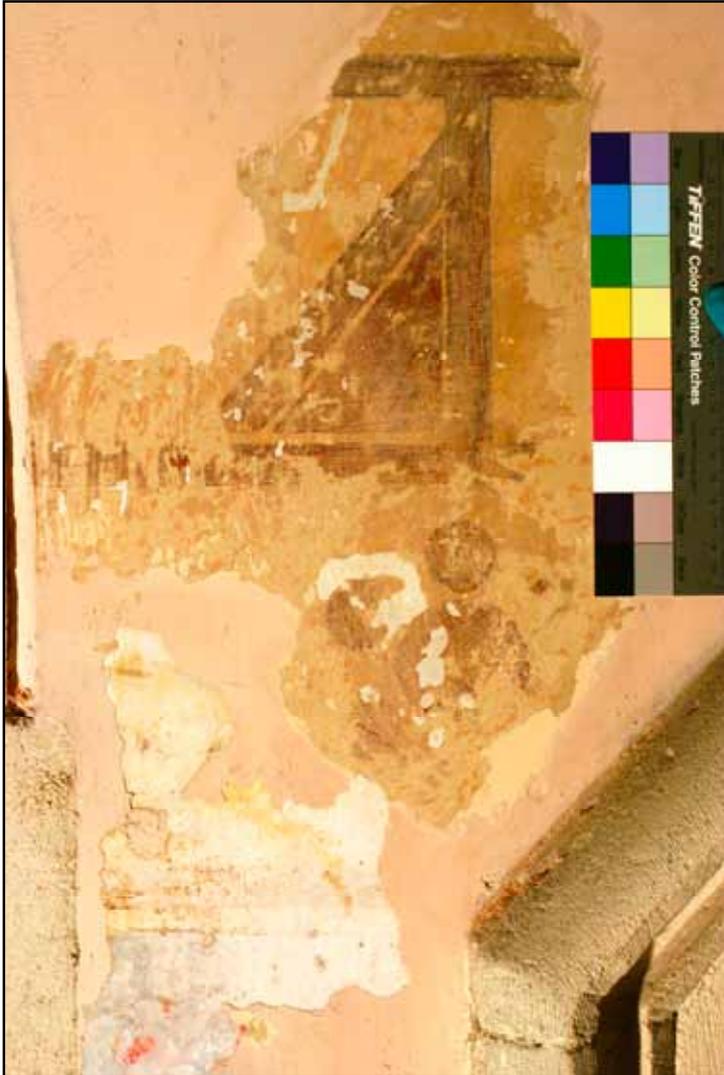
## Sample Area D

This area of original wall painting was revealed by first scalpel and then paint stripper. This revealed a large amount of original material and the decorative scheme can be seen to match the historic image.

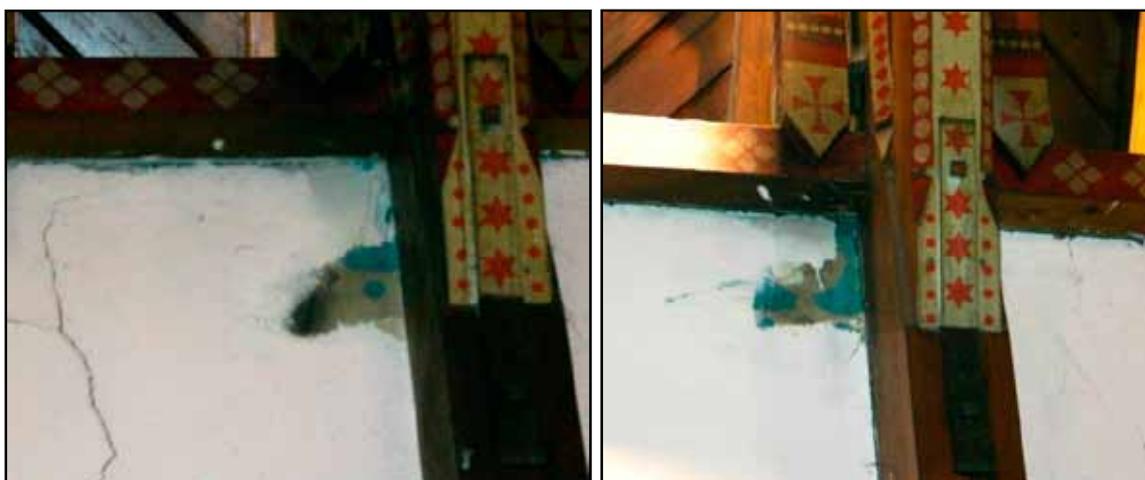
At the top of the wall over areas E and D there are two patches of the original colour scheme revealed. These show the original blue, yellow ochre and burgundy-red colour scheme as well as the ball motif.
