# Holy Trinity Church

*Avonside, Christchurch*

## CONSERVATION PLAN

6 March 2009

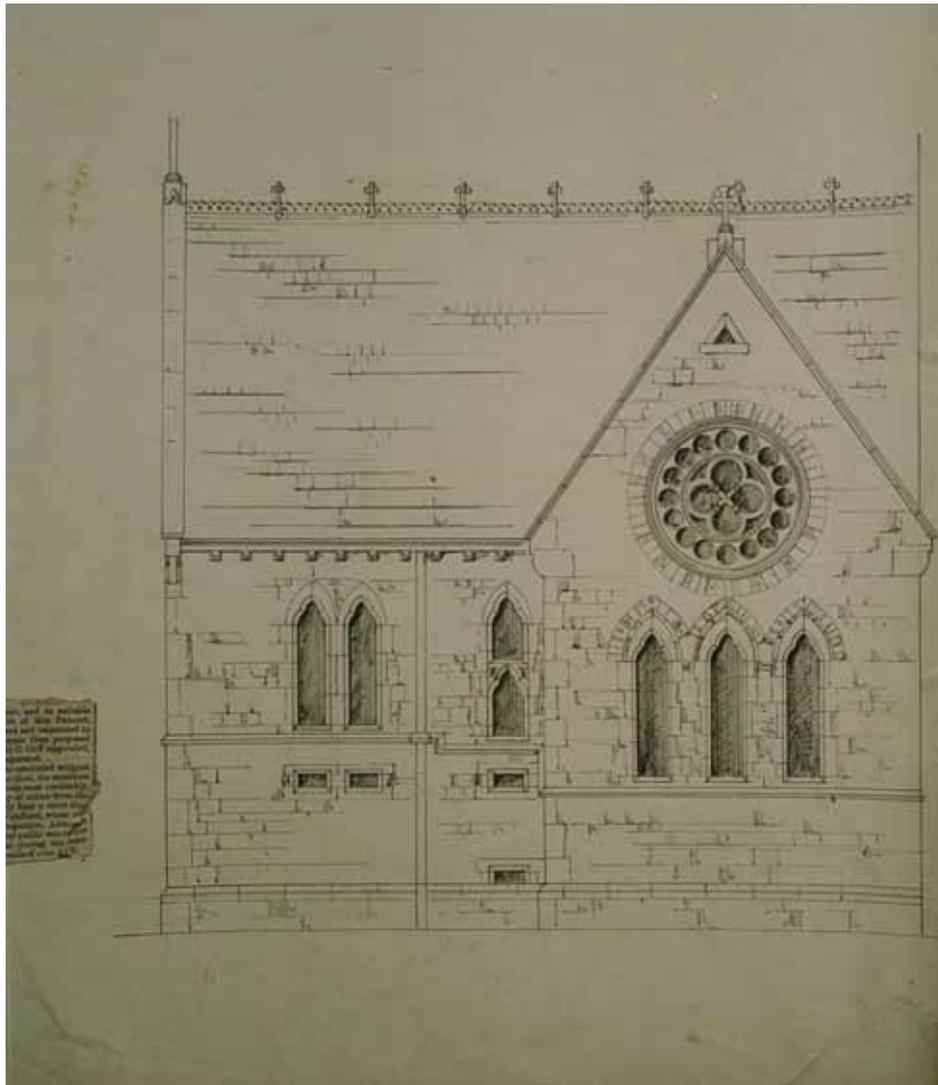
North elevation of chancel, enlargement of drawing on p. 35. There were changes made to the north elevation shown on this drawing, as the north minor transept was built with its gable facing east rather than north as shown.

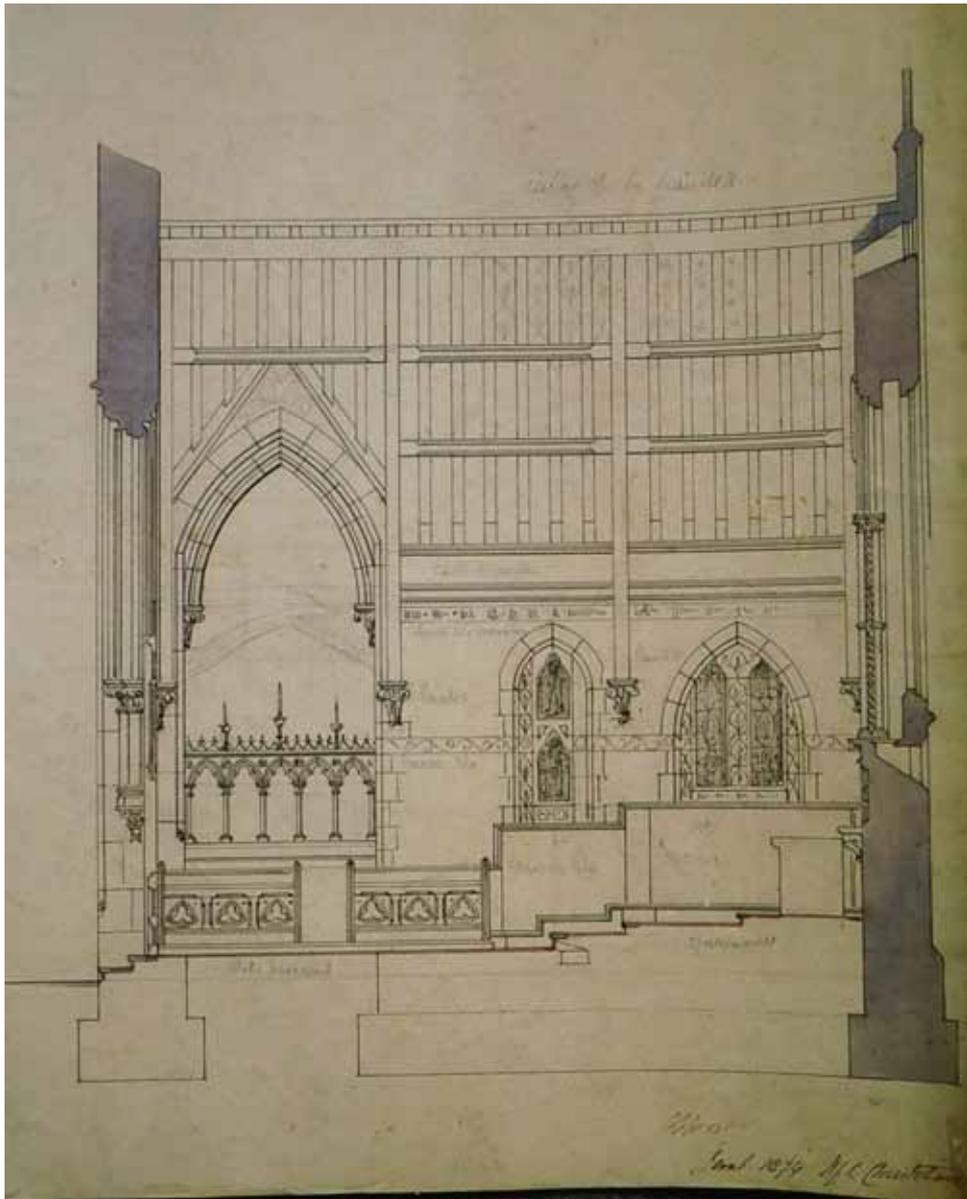
Long section of chancel, enlargement of drawing on page 35. The section is useful in confirming the location of steps in front of the altar and at the chancel arch. It identifies 'mosaic tiles' to be set in the wall in three locations (which is confirmed on site); 'painted' surfaces either side of the windows, and 'coloured tile inscription' above. These painted surfaces still exist, but are covered by modern paint coatings.

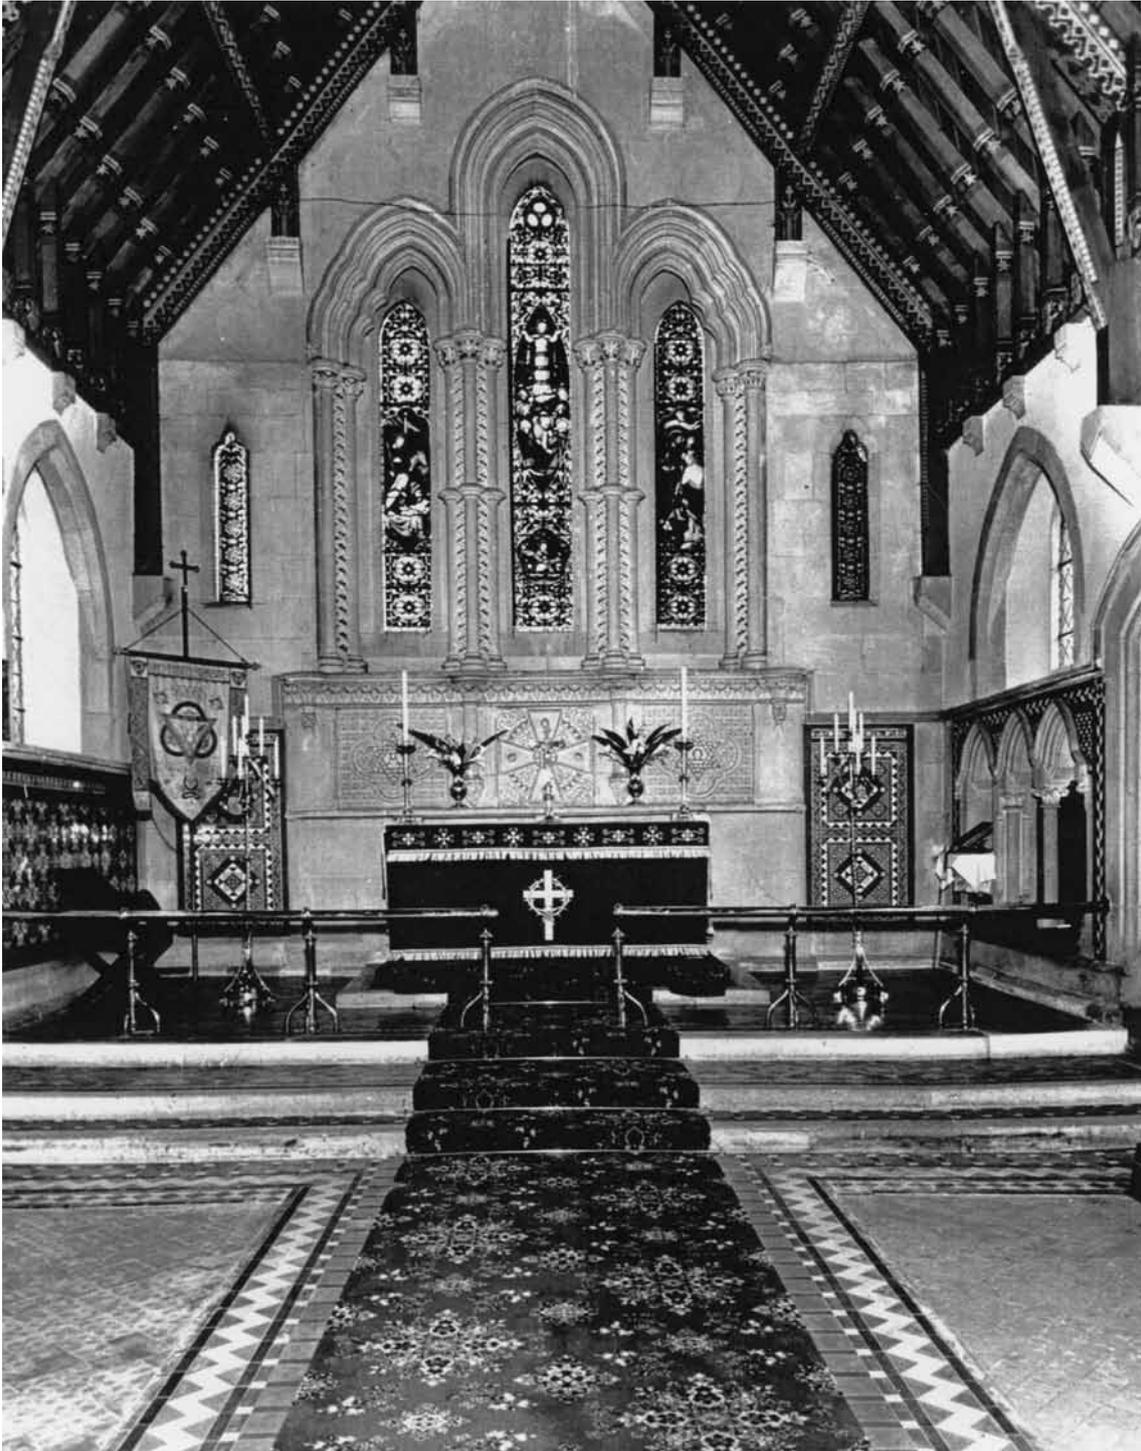
Holy Trinity Church, Avonside, 1960s. View of the chancel looking east. Floor tiling is completely intact, and the altar rail is still in its original location; the wall surfaces above the dado have been painted.

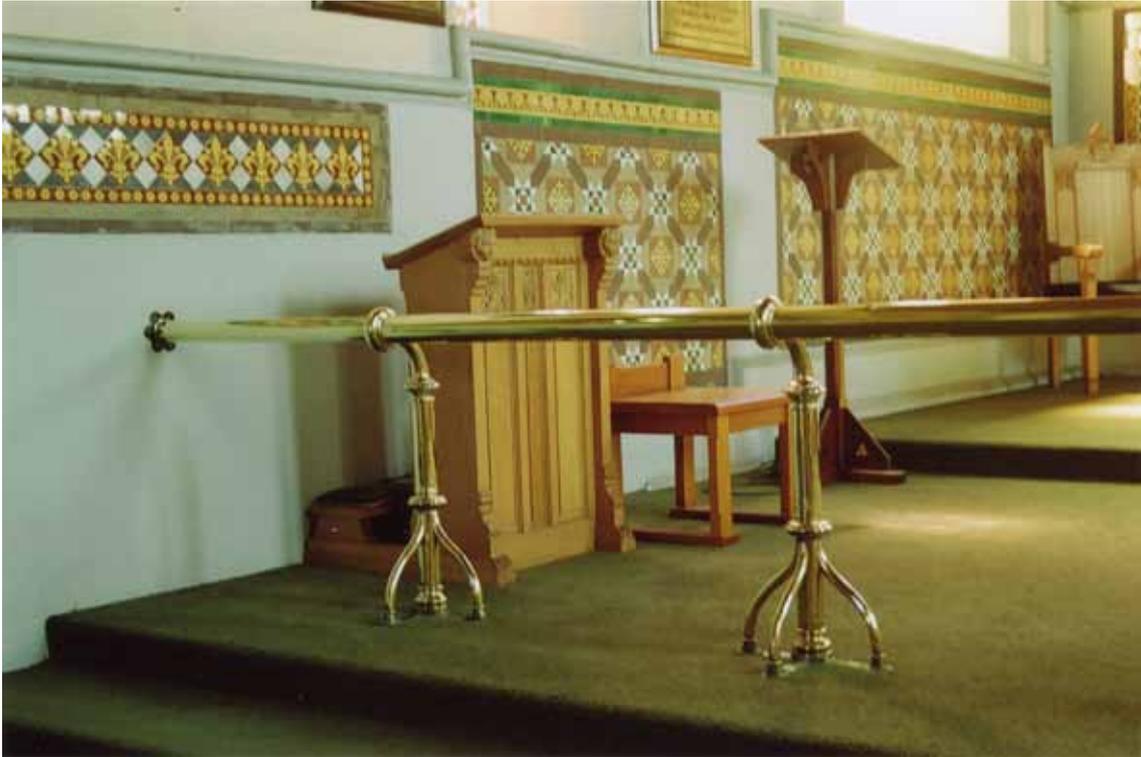
Altar Rail and the three panels of wall tiles on the north side of the chancel.

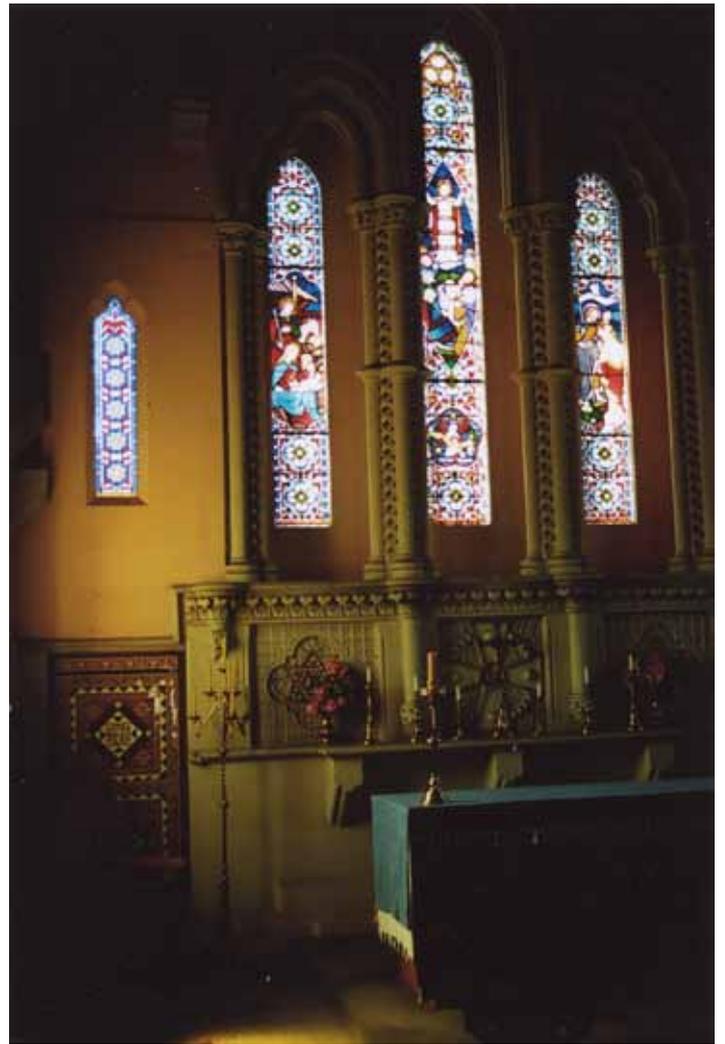
East Windows. Decorative carving and an unusual 'double skin' construction make these windows a unique feature of the chancel and the church. (See the Mountfort drawing for a cross section of this wall.)

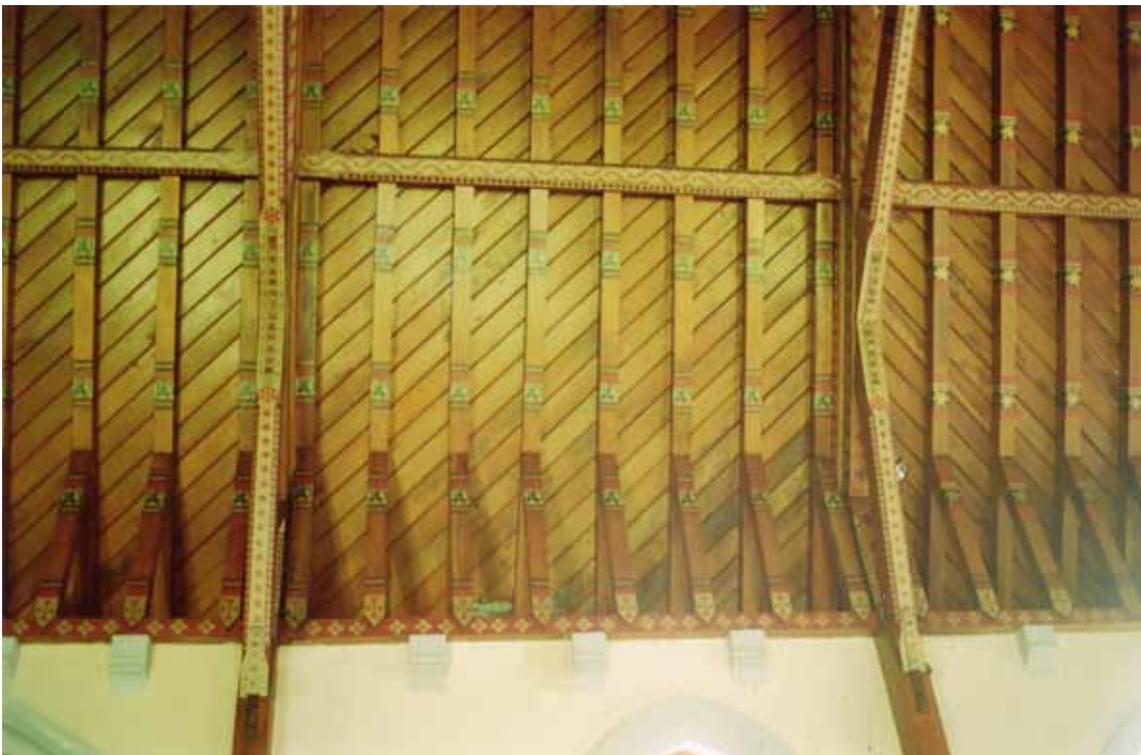
Chancel Roof. All truss members, purlins, rafters and props have painted decoration, which is in good condition.

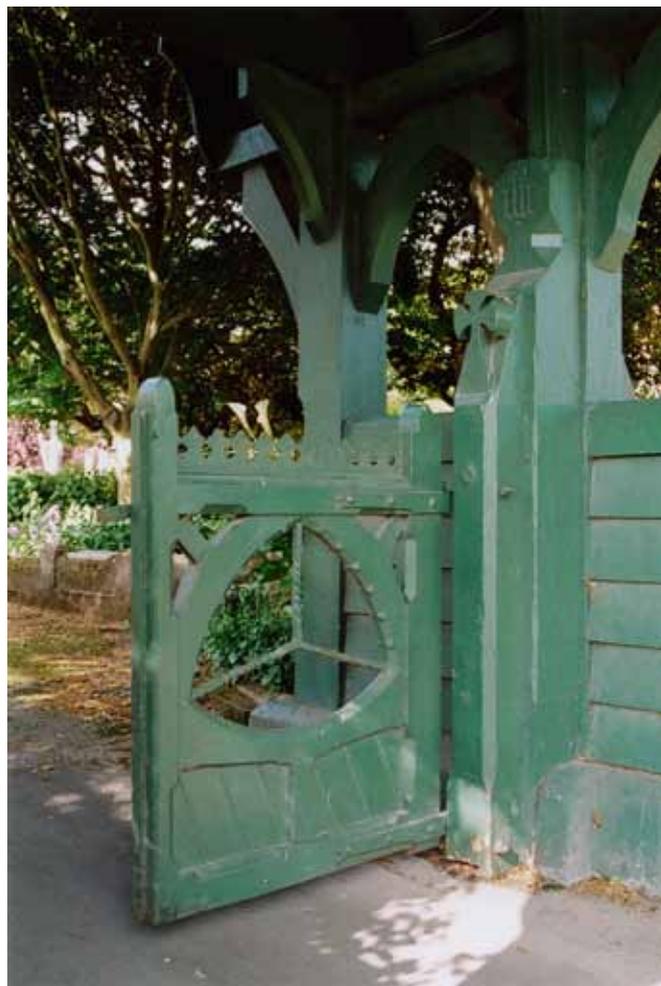
The north gate is in good condition, in need of minor repair. The timbers of this gate may originally have been unpainted.

Detail of the north lychgate, showing carefully executed timberwork, carved and chamfered.

I will undertake further research on these two structures, and provide more detailed recommendations for their treatment.

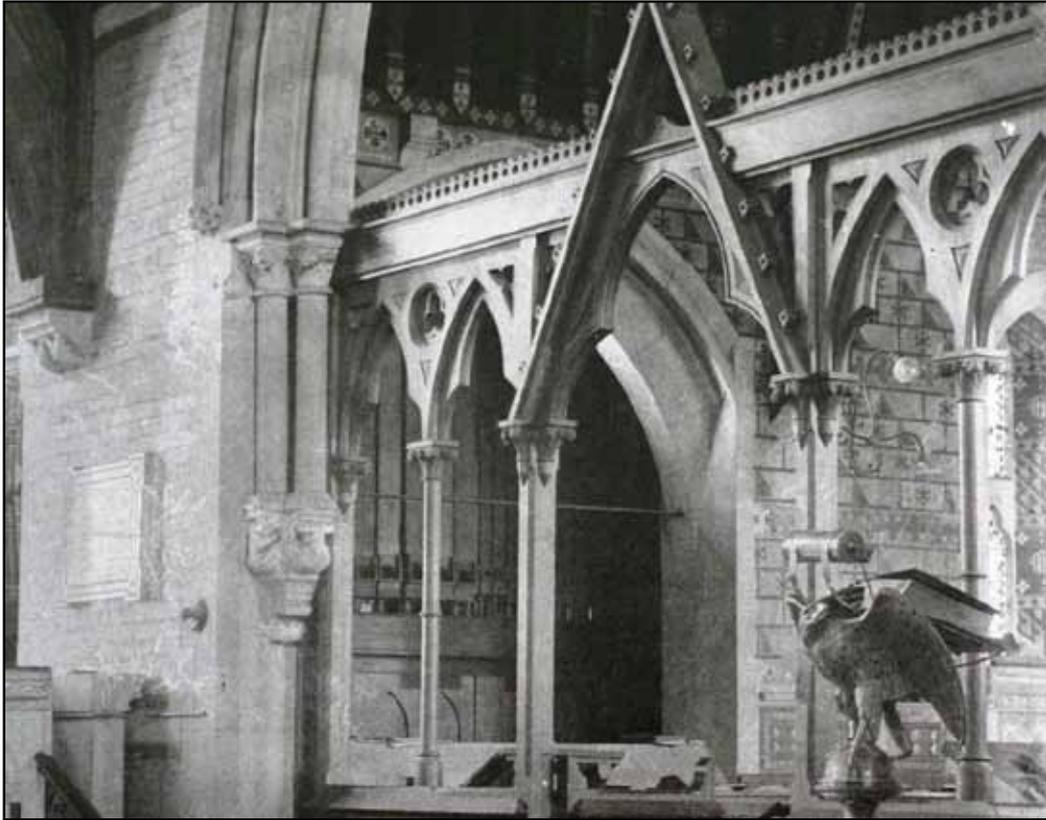
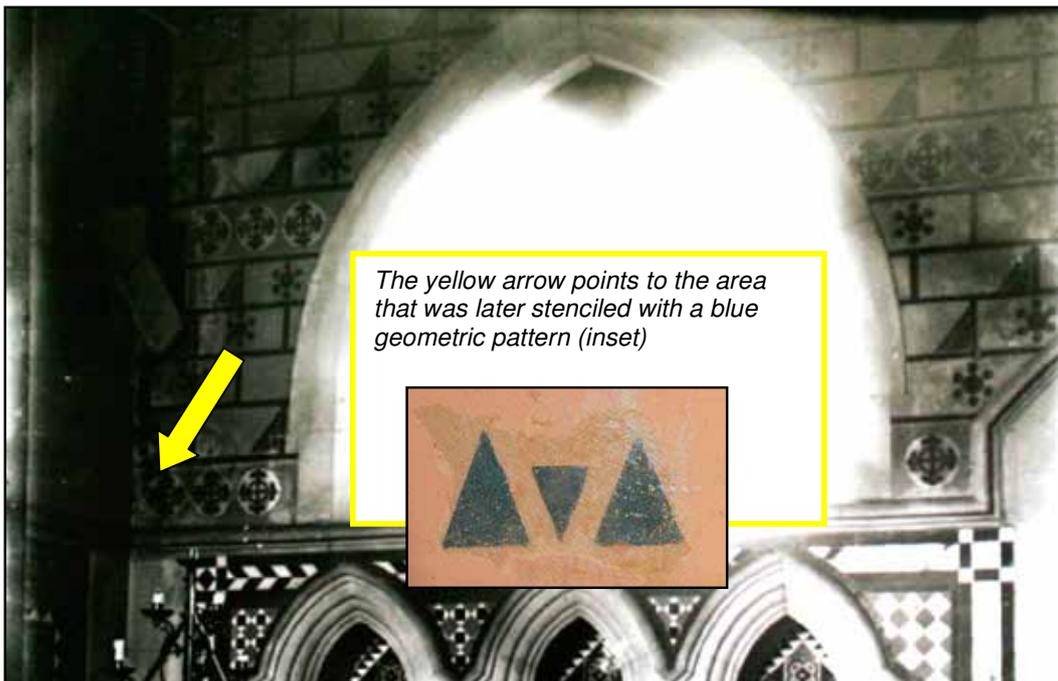
B.W. Montfort is credited as having designed and possibly executed the polychrome stencil wall paintings on the walls of the chancel now painted pale pink. Historic images support this. The blue geometric design revealed by Chris Cochran is at variance with the evidence of Montfort paint schemes in the photos published in the Conservation Plan and must therefore be considered as dating from a later renovation.

The original Mountfort wall paintings are therefore under several layers of more recent paintwork. Historic photographs show that the original scheme incorporates three distinct designs set into a geometric pattern resembling ashlar stonework, the whole complementing the design found of the tiling and the stenciled painting on the timberwork of the roof. Very little of this decorative scheme is now visible due to the over painting and much of it must be considered lost or fragmented due to earlier damage and water ingress.

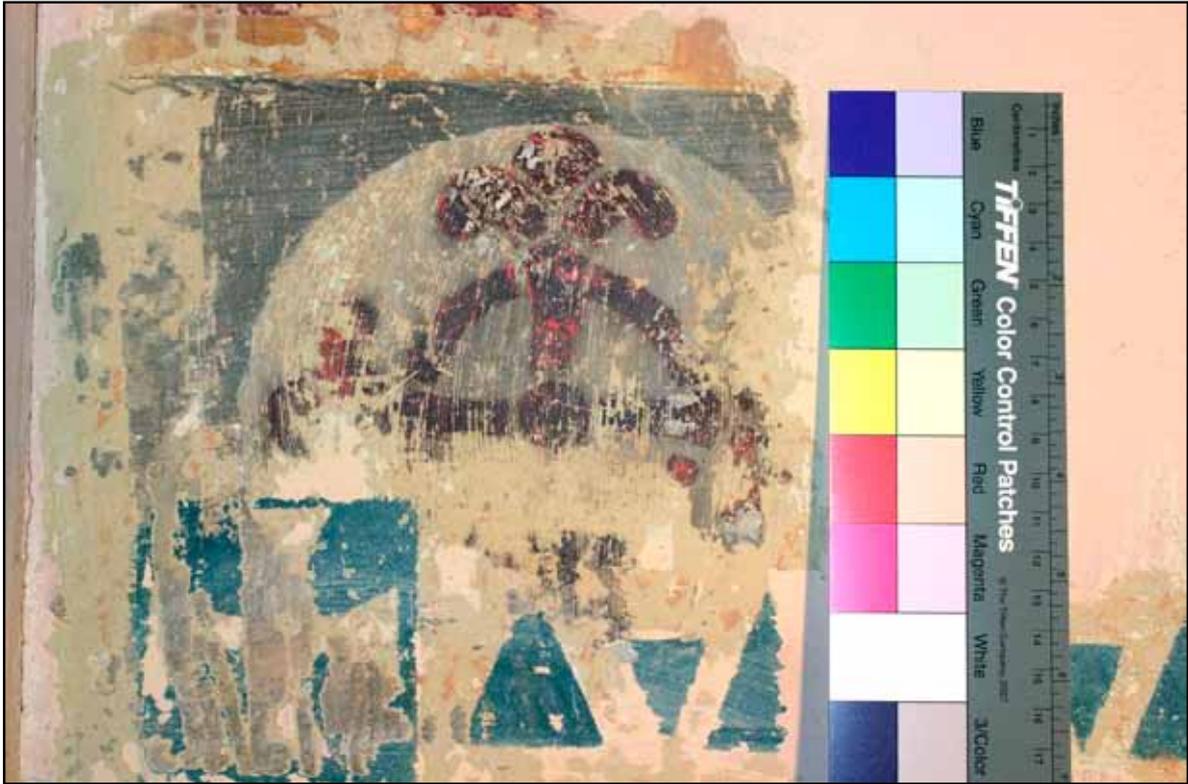
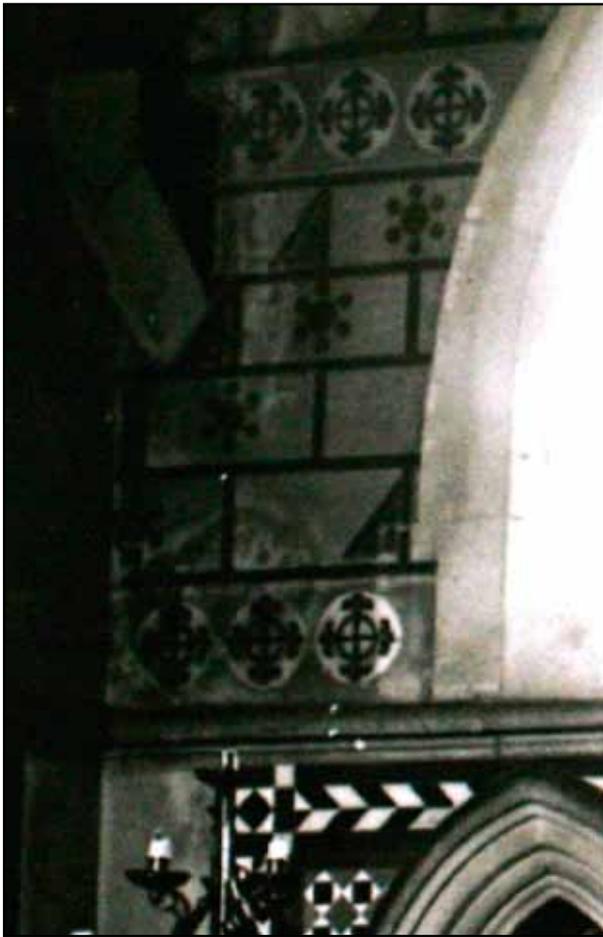
The original design as shown also in the historic photo reproduced in the Conservation Plan was revealed underneath the blue triangular stenciling

The original design revealed, as documented also in the historic image (enlarged details on left and below)

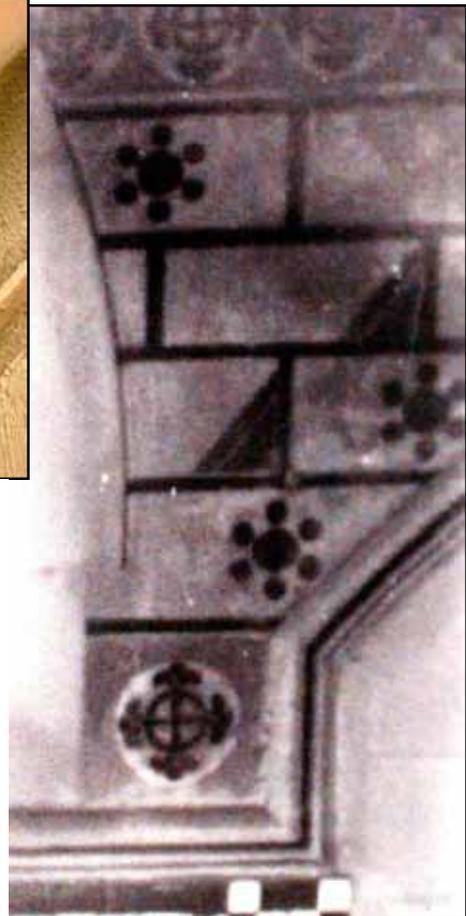
This area of original wall painting was revealed by first scalpel and then paint stripper. This revealed a large amount of original material and the decorative scheme can be seen to match the historic image.

Note also the 'ball' or flower design below the triangle.

Colour sequence associated with triangle design:

Triangle and ca 20mm wide lines are a red ochre which is not easily soluble in a variety of solvents or paint stripper.

The first non original paint over this design is a thick coat of grey-green paint which is removable with paint stripper but resistant to solvents. There are at least two top layers of a pale pink paint which are soluble in acetone and alcohol as well as readily removed with paint stripper.

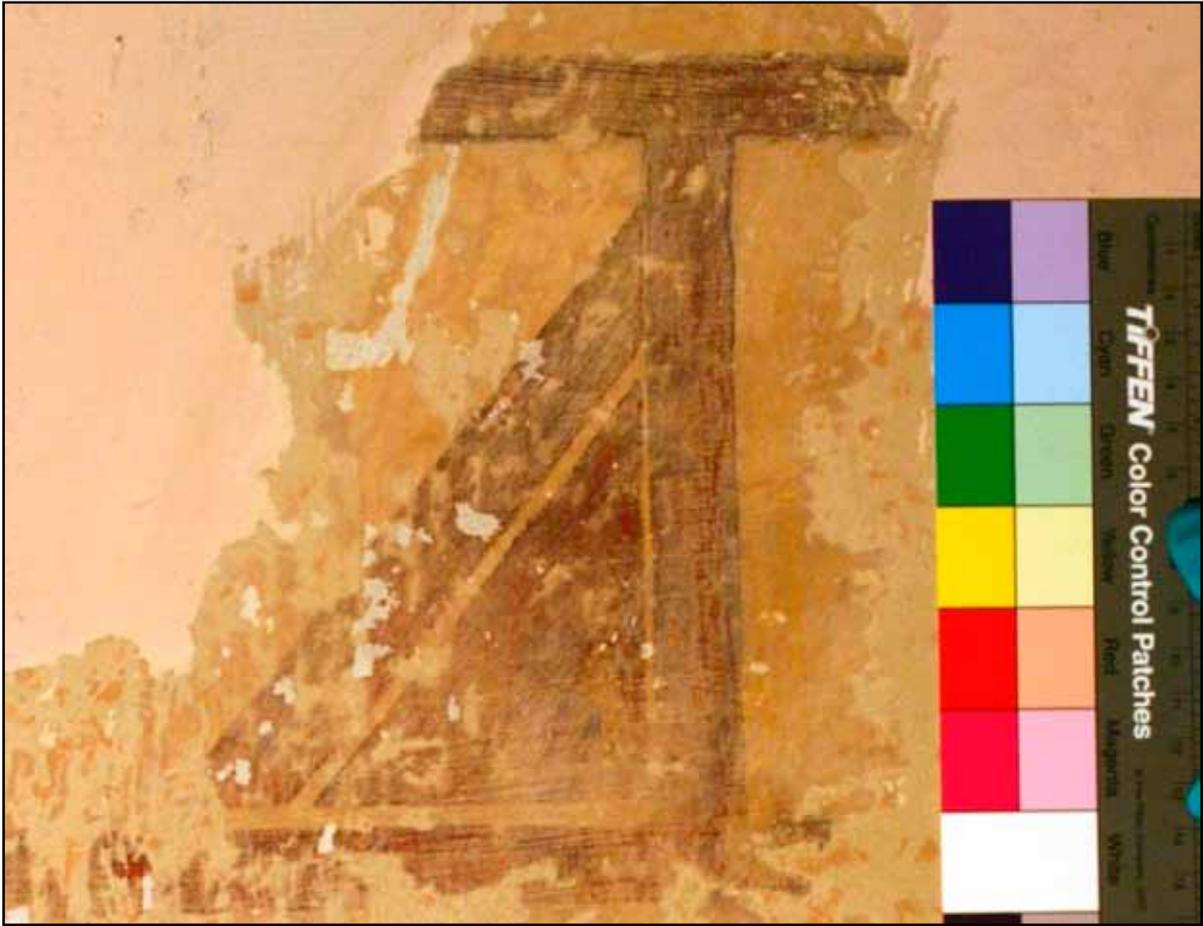
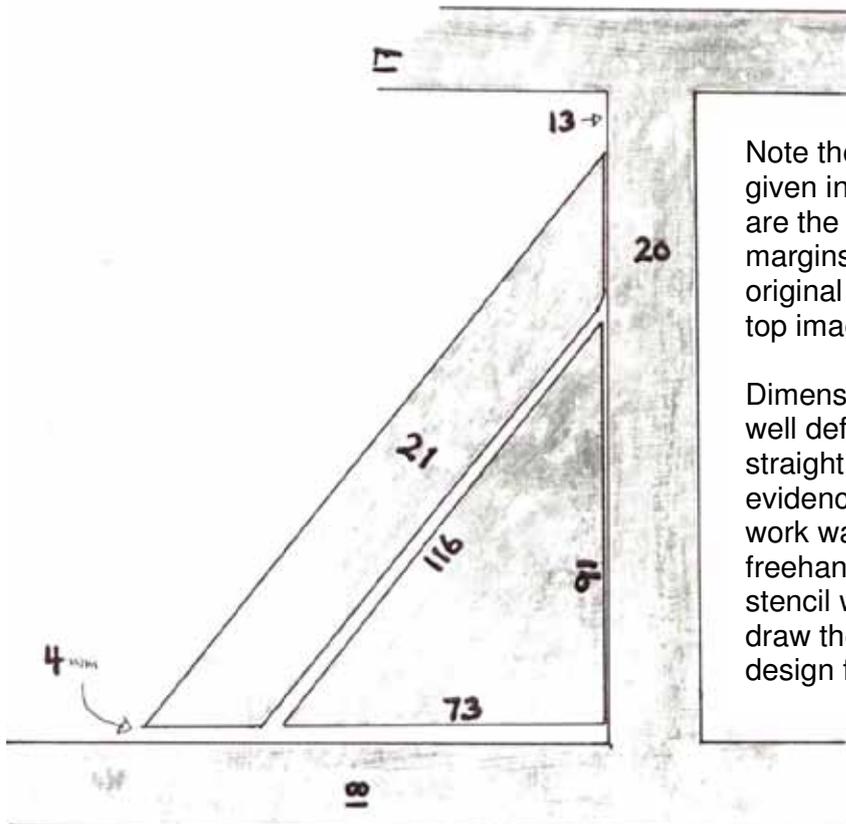
Note the measurements given in the drawing: these are the actual width and margins measured off the original wall painting in the top image.

Dimensional variations and well defined but less than straight lines are clear evidence that the paint work was carried out freehand, even though a stencil was likely used to draw the outline of the design first.

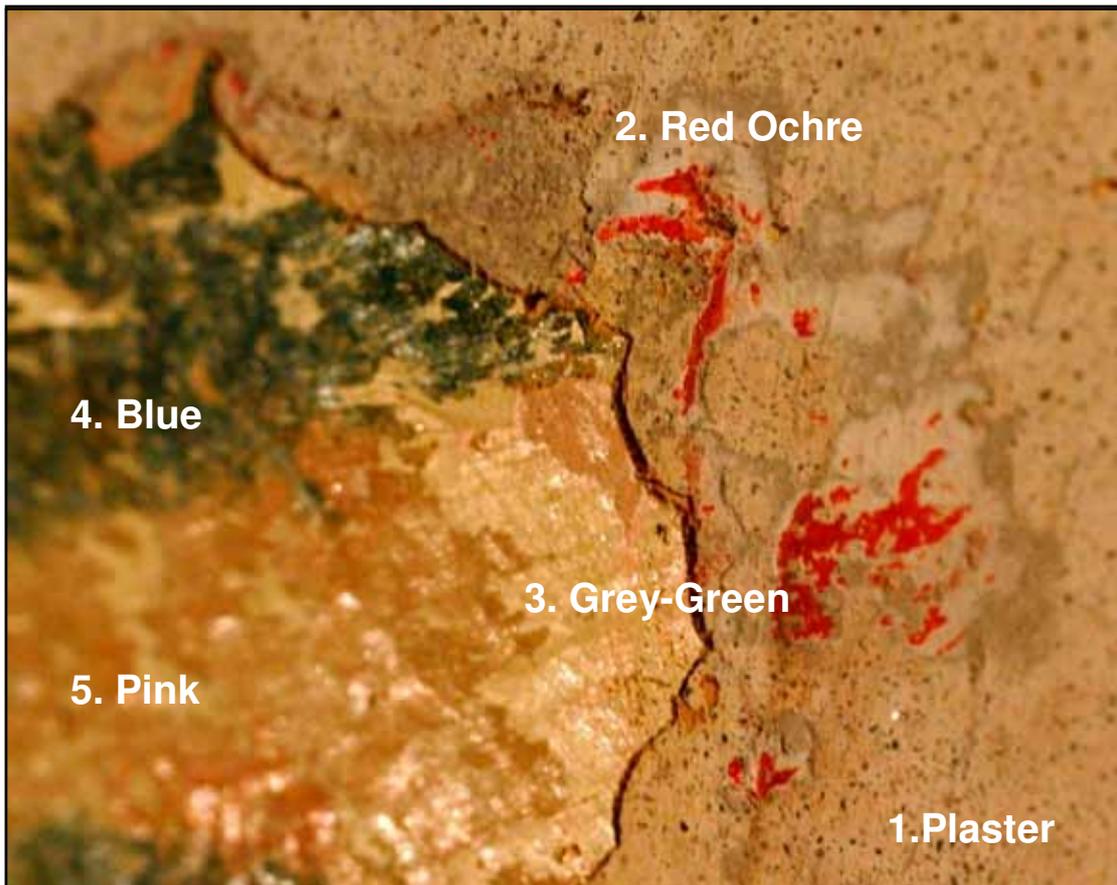
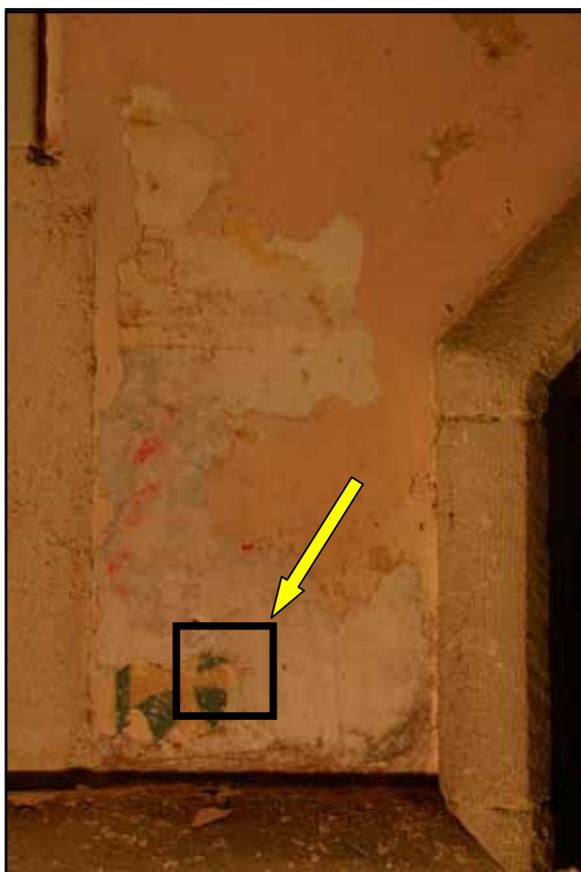
1. Plaster or render on stonework, very thin
2. Red Ochre – part of the original wall paint design
3. Grey-green paint – glossy, very thick and sticky when affected by paint stripper, therefore very likely an oil-resin based paint
4. Blue – non-original geometric stenciling directly underneath the top layers of pale pink paint
5. Pink – easily removed, probably acrylic
